# Shaft Voltage and Current Phenomena in Turbo generators: Case Study of Post-Overhauling Bearing Anomaly at a 210 MW KWU Turbine Set

*Case Study of Post-Overhauling Bearing Anomaly at a 210 MW KWU Turbine Set*

**Shobhan Kumar Malana, Suryabali**  
Sr. Manager, BHEL, Sr. Engineer, BHEL  
Bharat Heavy Electricals Limited, Varanasi, India  
[shobhan@bhel.in](mailto:shobhan@bhel.in), [suryabali@bhel.in](mailto:suryabali@bhel.in)

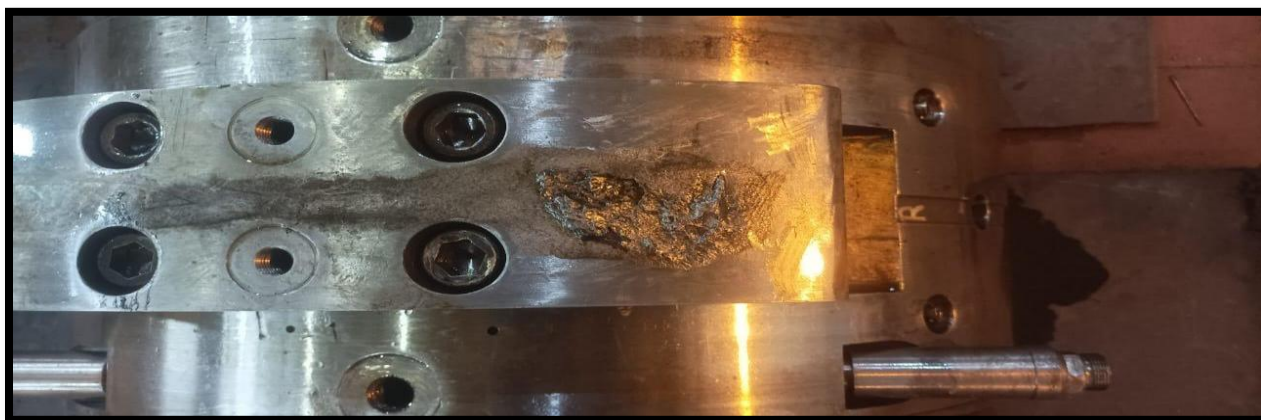
Figure 3: Electrical discharge markings at bearing torus support.

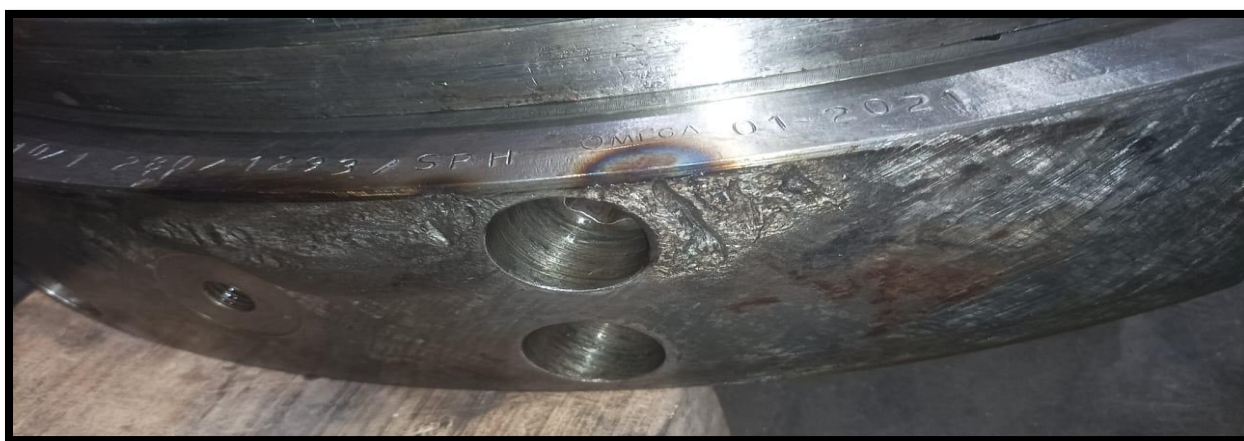
Figure 6: Discharge evidence at torus contact surface.

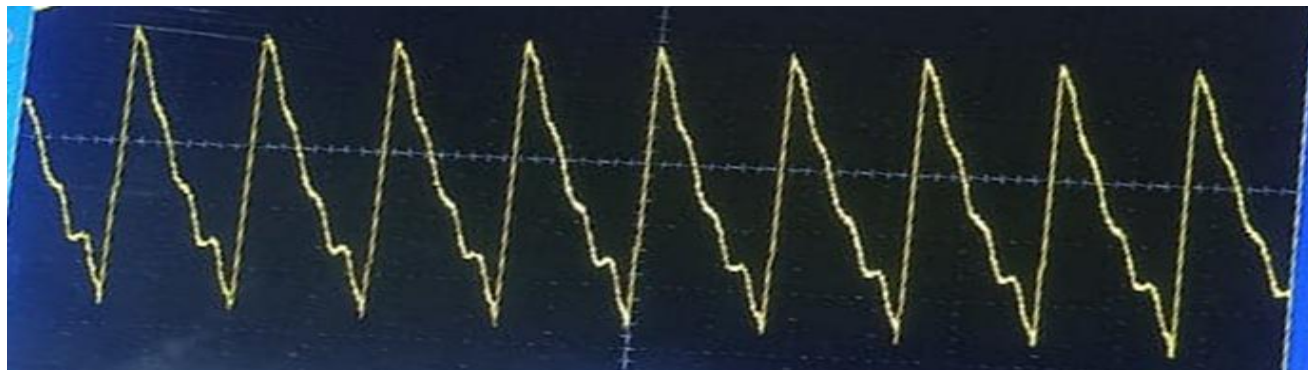
**Spectral discrimination.** To isolate the excitation system as a source, the exciter and shaft-voltage waveforms were compared. The exciter showed a **pulsating DC component at 300 Hz** (6-pulse rectifier ripple), whereas the shaft-voltage spectrum **lacked a coherent 300 Hz line**, indicating that static-exciter ripple was **not** the dominant contributor under these conditions. With **stator loading**, a **low-amplitude, slowly varying AC influence** on the shaft voltage was detectable, but its magnitude remained small relative to the 50/100 Hz induction signature and impulsive events.

Figure 9: Pulsating Excitation Voltage 300 Hz
