Determination of Automotive Brake Disc Thickness Variation To analyses Judder Issue

Abstract: Now a day's Vehicles are becoming more powerful and resulting high speed. But due to road limitation sudden braking is also repeated in RWUP condition and because of that minor variation in brake disc causes vehicle brake juddering and results in driver discomfort & poor confidence. It is directly affecting on business performance. Even though advanced technologies are available in market still it is impossible to designed brake disc with zero variation. Vehicle juddering has become of major concern to automobile manufacturer world wide and braking performance not consistent due to brake disc variation. Brake Pad that will enable engineers to better understand the causes of DTV & Stick-slip the initiator of low & high frequency vibration in motor vehicle brake. DTV is caused by disc brake pad wearing the brake disc, at their point of maximum run-out through continual light rubbing whilst the brake of the vehicle is not applied, thus wearing two relatively thinner areas of the disc- one on each rubbing face- at diametrically opposite points. If sufficient thickness variation is generated i

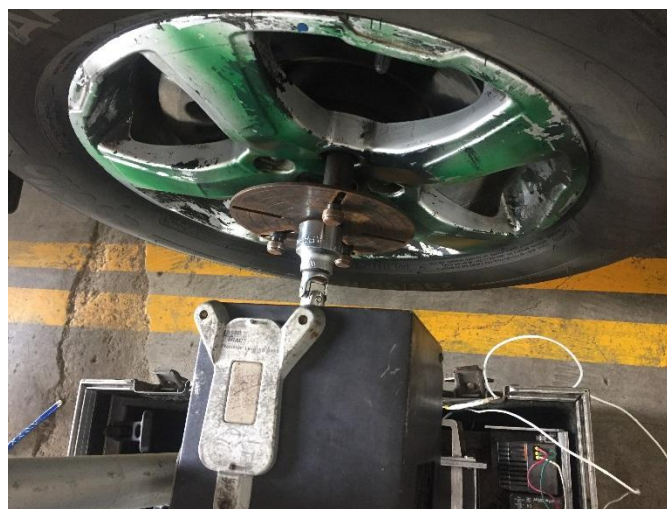
Figure 3. Wheel drive adaptor with fixture plate

Wheel drive adaptor mounted on fixture plate that attached on the wheel hub (as shown in fig 2). and two capacitive probes are mounted on vehicle with help bracket and this bracket is mounted on knuckle (in fig 4& 5).

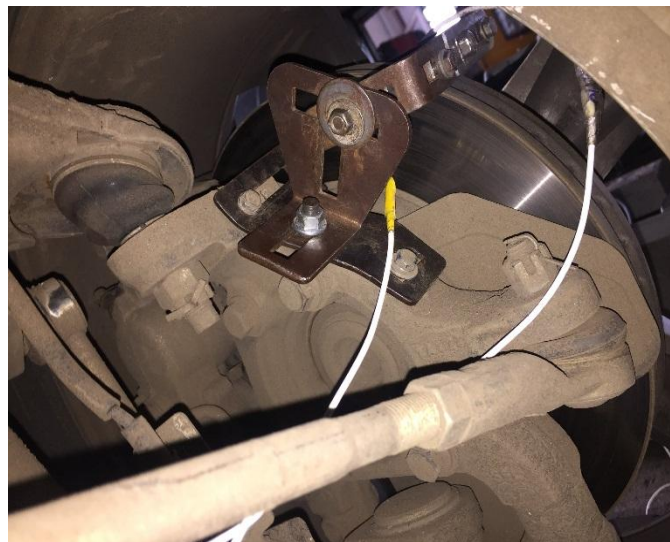
Figure 4. Capacitive probe with bracket (Inner side)

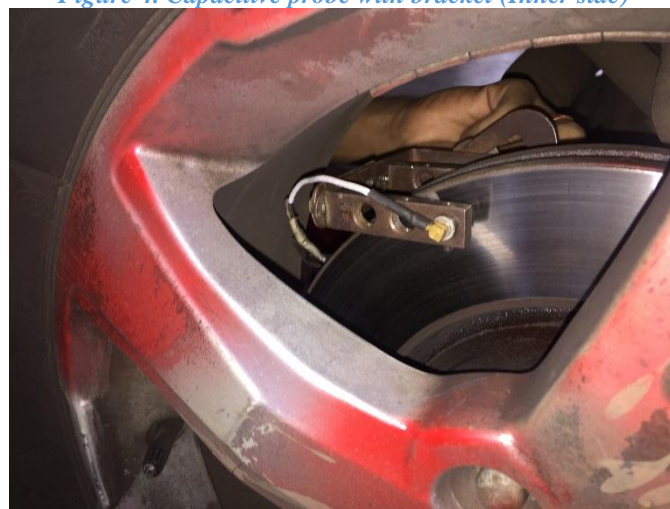
Figure 5. Capacitive probe with bracket (outer side)

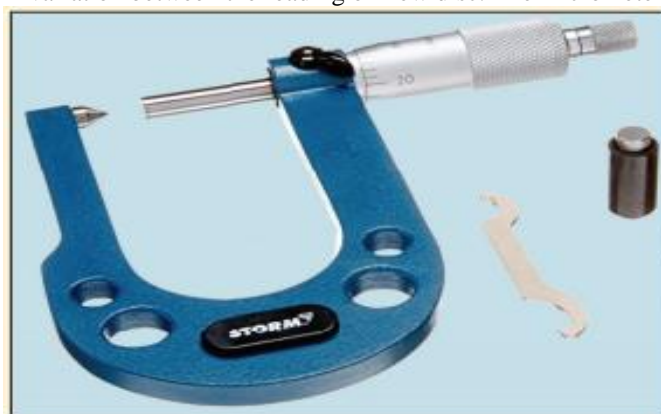
Figure 6. Brake Disc Micrometer

Brake Disc Micrometer- it is specialized micrometer designed for this purpose. It's throat deep will be deep enough to measure disc thickness at several points across the disc. This gauge will have one or more pointed anvil tips that allow you to measure true thickness of the disc, starting at the bottom of any deep grooves. Measure the disc thickness by marking the rotor in at least 8 to 10 equally spaced intervals. A disc that's in good condition shows variations in thickness of no more than 1 to 3 microns[23]. There should be no more than 1 micron in variation between the reading on new disc. The micrometer used for this is shown in fig 6 -

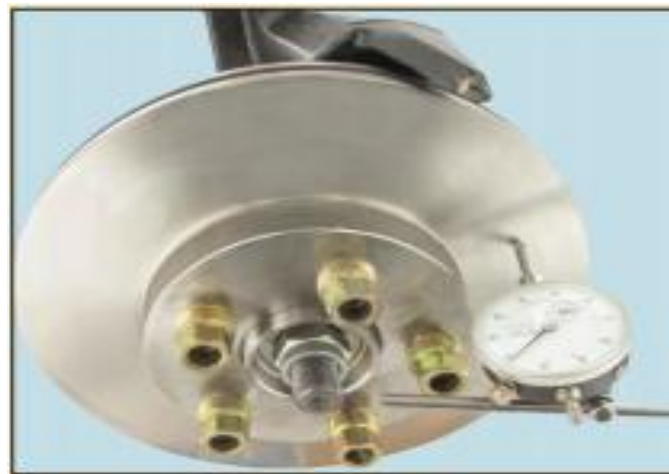
Figure 7. Dial Indicator with Brake Disc

Dial Indicator- Rotate the hub bearing assembly by hand. Check for roughness, play or noise from bearing. The hub is directly affected by the condition of the bearing. If a dial indicator measurement of bearing end play is greater than 4 microns, the bearing is suspect. A worn or loose wheel bearing will contribute to hub and disc runout. Set the dial indicator to zero, next turn disc at least twice and observe the high and low spot of runout. Mark these spots on the disc. If disc shows runout greater than 50 microns or if the readings are inconsistent corrective action may be needed. Some poorly manufactured disc may reach or exceeds this limit with brand new[23]. It working process is (shown in fig 7) -

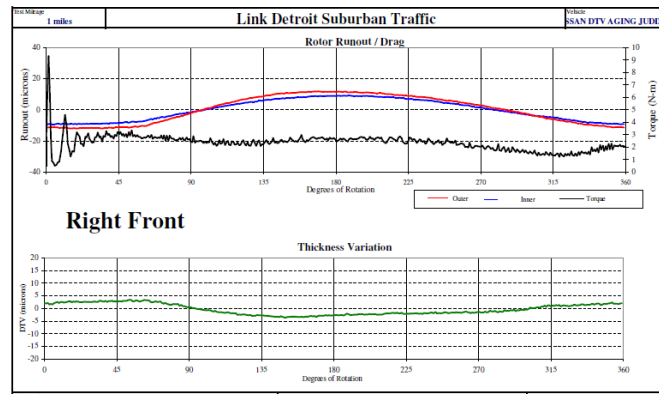
Figure 10. Disc Thickness Variation measurement for RH side at Disc Top[23]

DTV Data Analysis- Once DTV measurement data is acquired the next important parameter is analysis of this data. We acquired data in total 3 vehicles for both LH & RH side disc at Top, Bottom and Mid location. It shows that top side run out is higher than bottom side at each disc. And also, total thickness variation of disc at each location is within 5 microns in each vehicle (fig 9, 10, 11).
